## ***ENGINEERING REPORT***

### **FAA CONTRACT NO. DTFA03-02-C-00044 PHASE 1, CLIN 0001f (TASK 6) - PRE-TEARDOWN INSPECTION REPORT**

This report supports Task 6 of FAA Contract No. DTFA03-02-C-00044. Various NDT and visual inspections were accomplished on panels which were removed from aircraft N474DA, a Boeing 727-232. The pre-teardown inspections were conducted after aircraft disassembly and prior to teardown and destructive testing. This report provides details and results of the inspections, including procedures used, locations and documentation of defect indications noted, detailed fastener parameters, condition of the panels after aircraft disassembly, and a comparison of the Field Inspections previously accomplished.

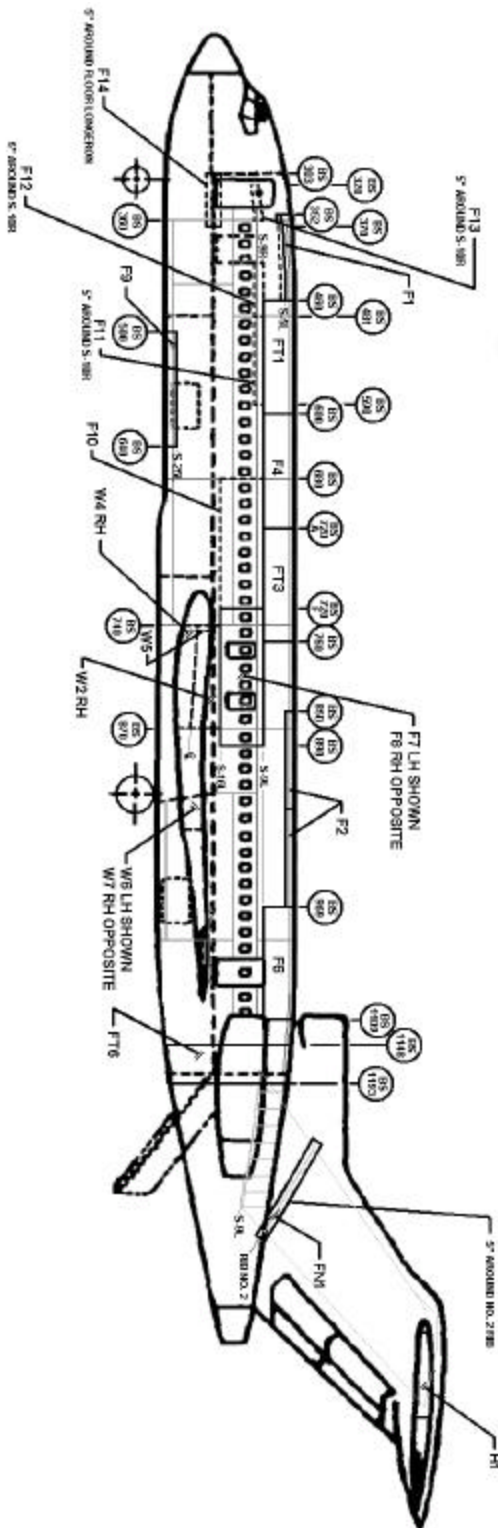
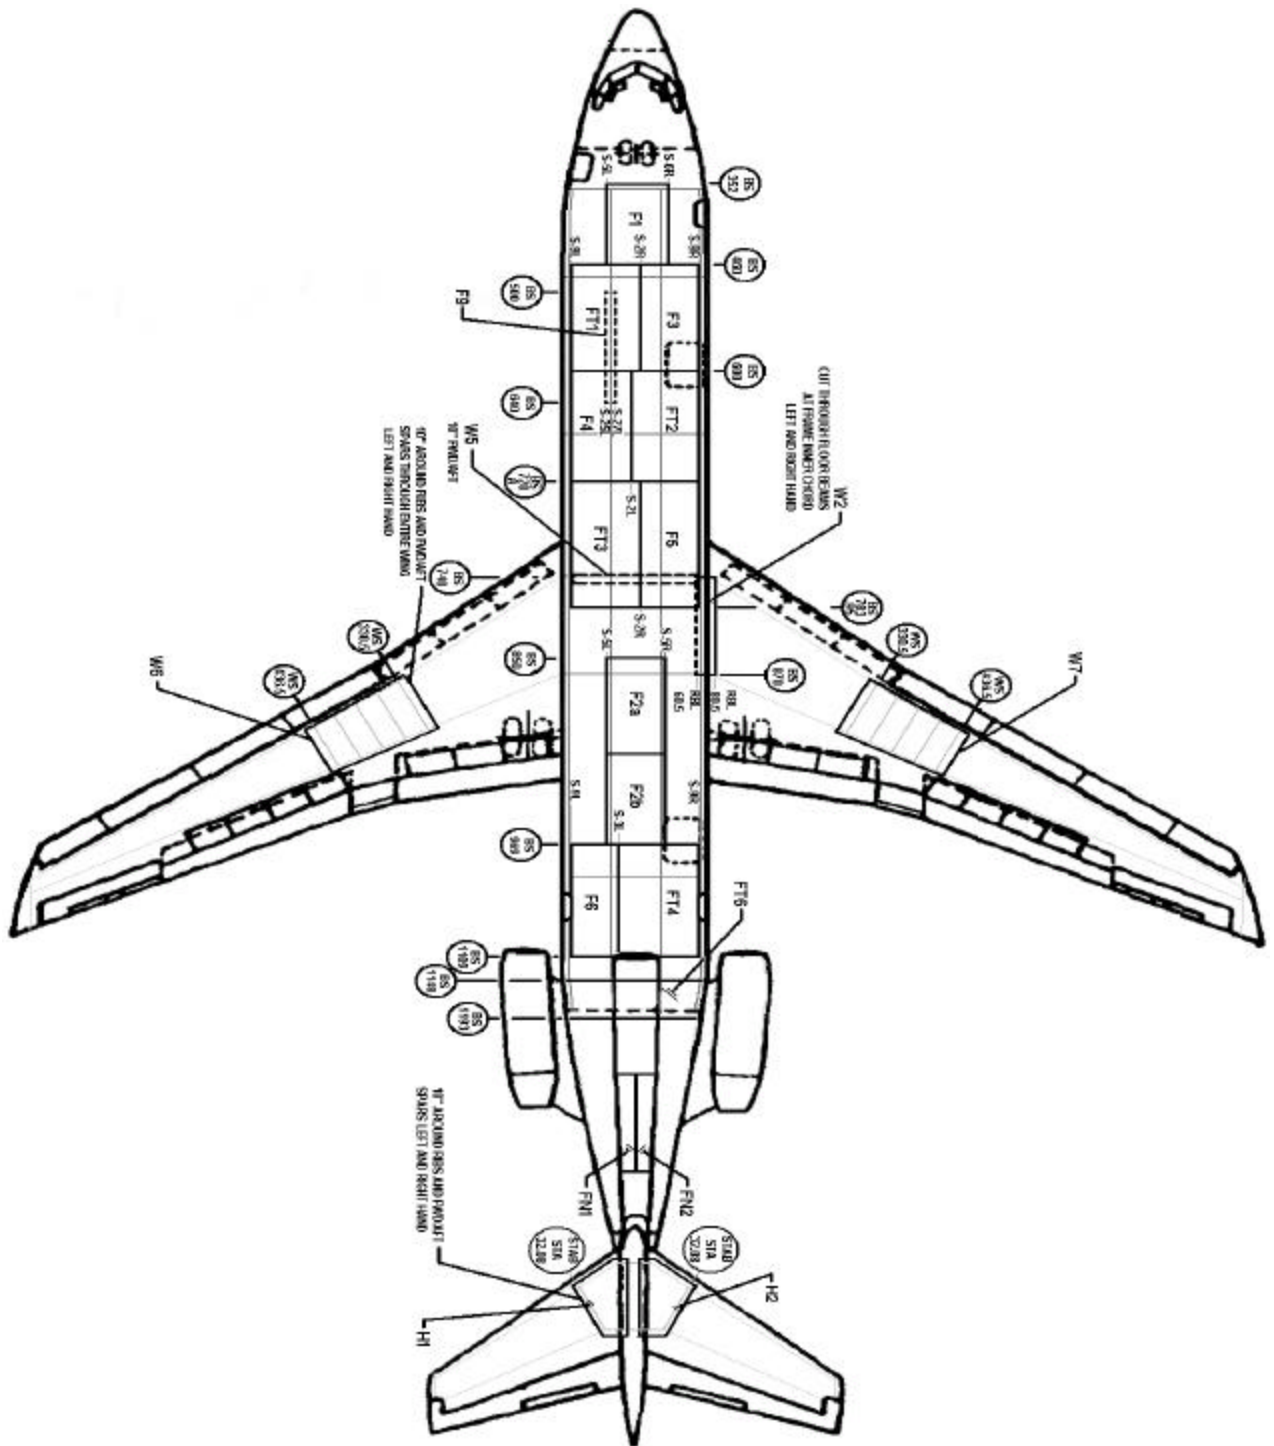
Figure 1. Overview of location of each panel removed from the subject aircraft (Sheet 1 of 2).

Figure 1. Overview of location of each panel removed from the subject aircraft (Sheet 2 of 2).

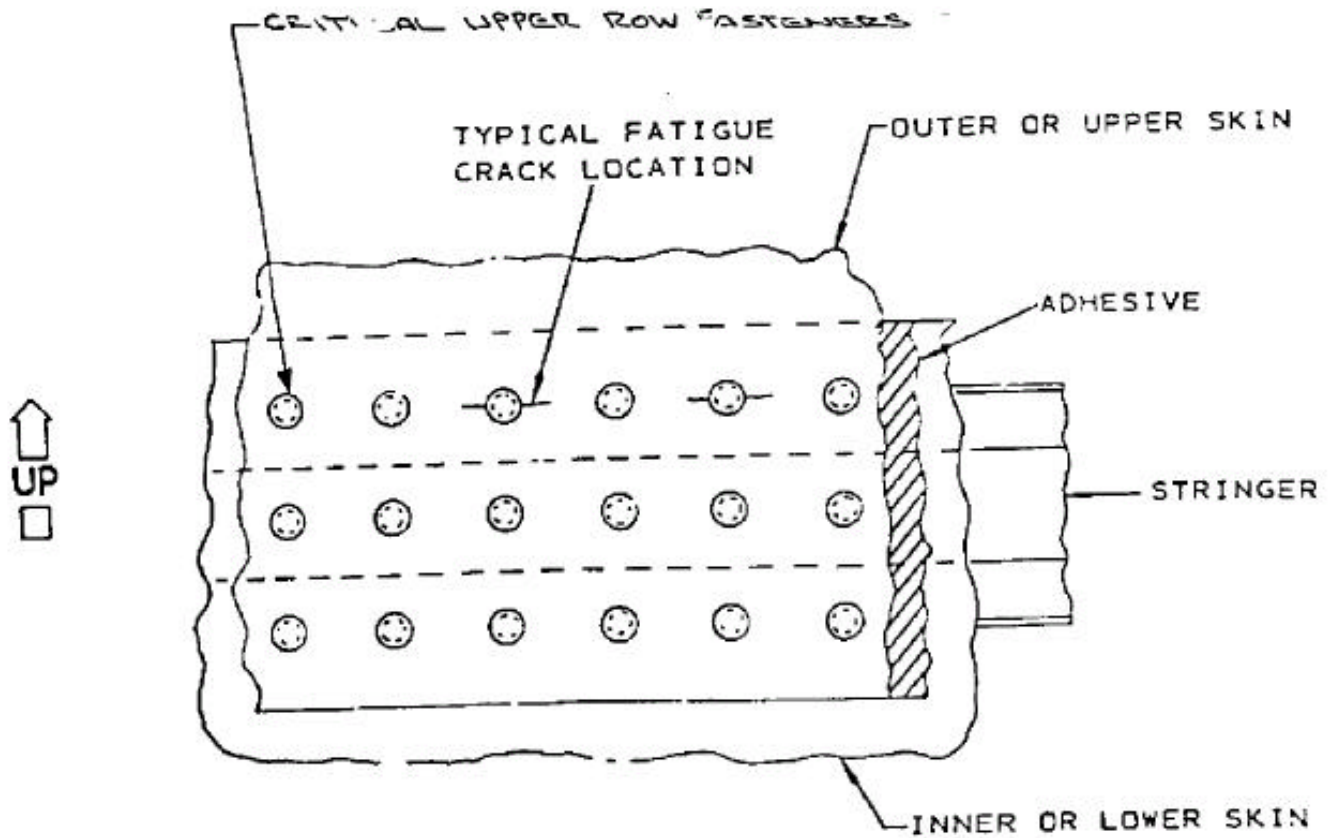
Figure 2. Schematic of typical cracking found in the upper skin, upper row of fasteners of longitudinal lap joints.

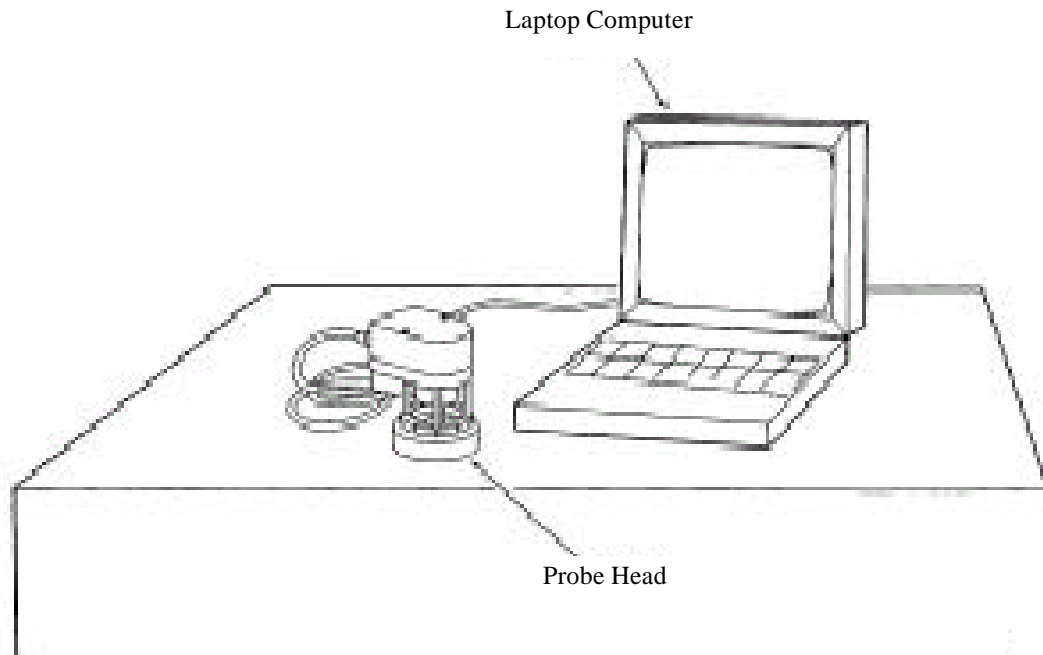
Figure 3. Schematic of the Rivet Check System (NASA Self-nulling probe) consisting of probe head and laptop computer.

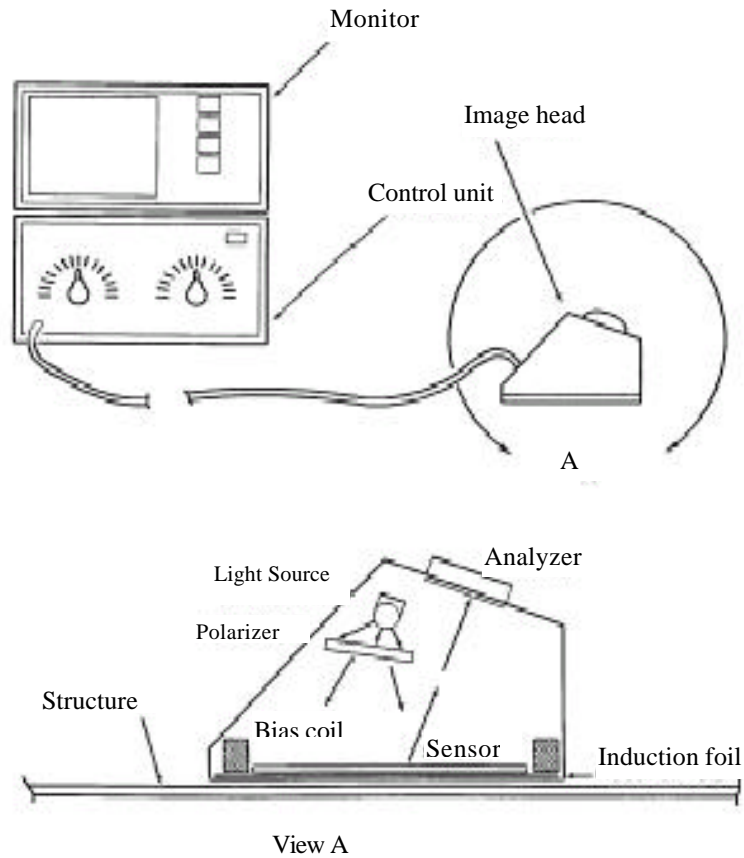
Figure 7. Schematic of Magneto Optical Imaging system consisting of hand-held imaging head and video unit.

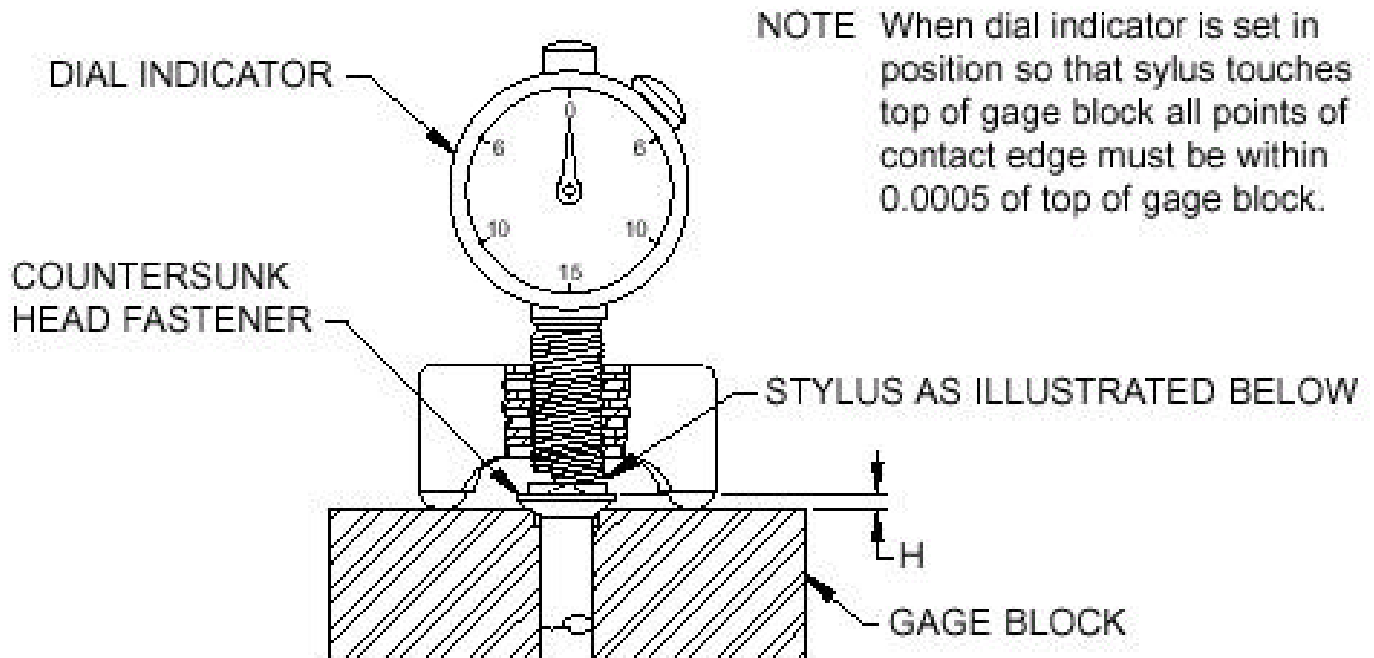
Figure 12. Schematic of flushness measurements via a dial indicator.

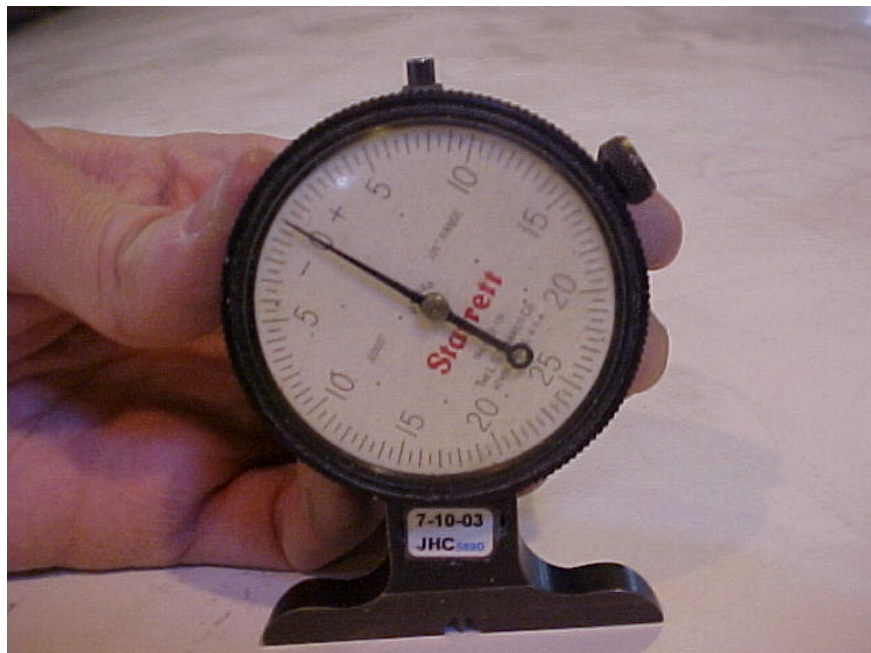
Figure 13. Photograph of dial indicator used for flushness measurements.

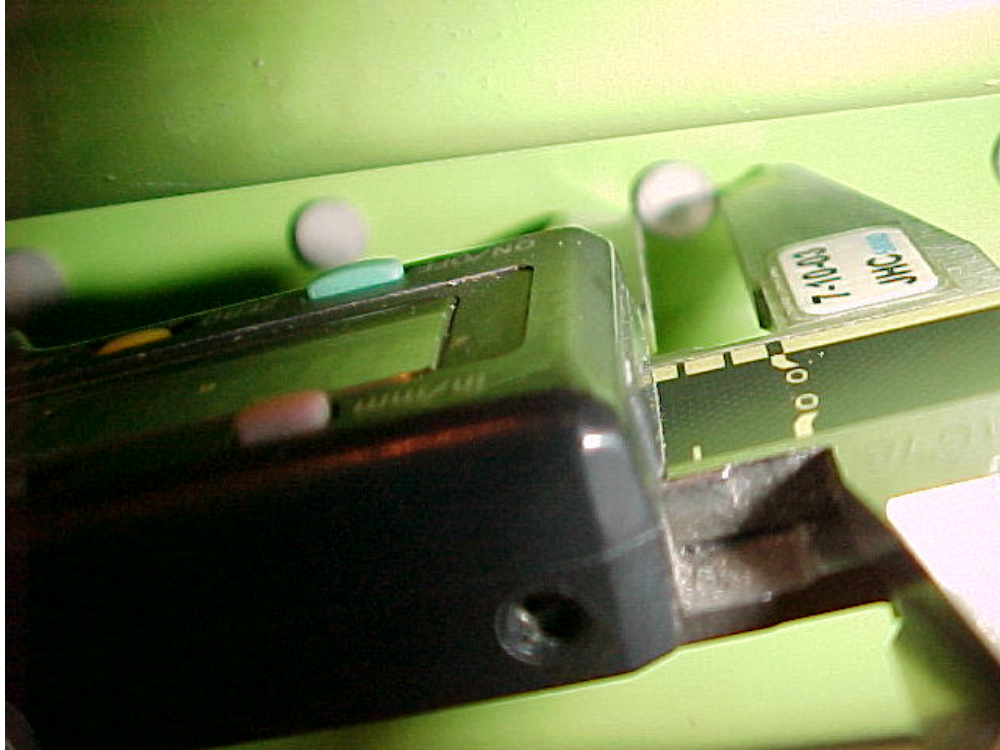
Figure 16. Photograph of digital micrometer used to measure fastener buck-tail diameter.

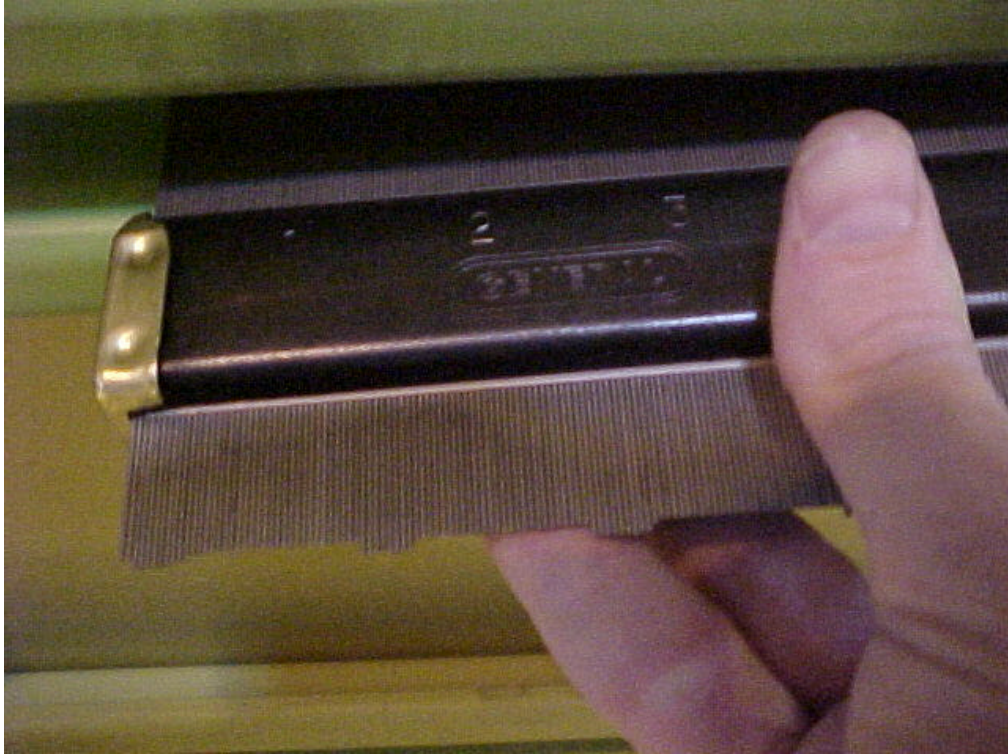
Figure 17. Photograph of depth gauge used to measure remaining grip lengths. A digital micrometer was used to measure the resulting protrusions.

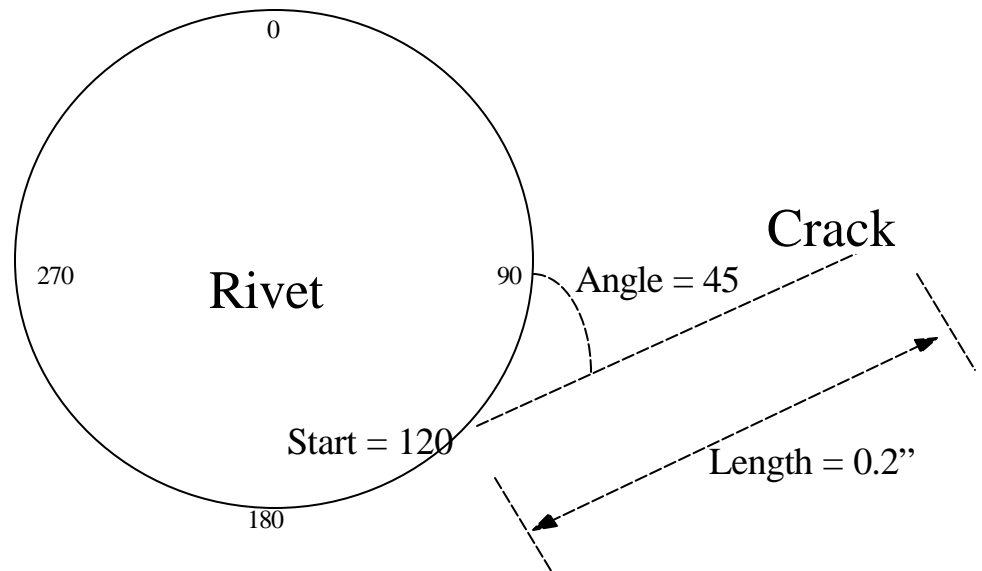
Figure 19. Schematic illustrating crack measurements: crack length, crack start orientation, and crack angle. For example, the crack orientation would be approximately 120 degrees, with a 45 degree crack angle for a length of 0.200".

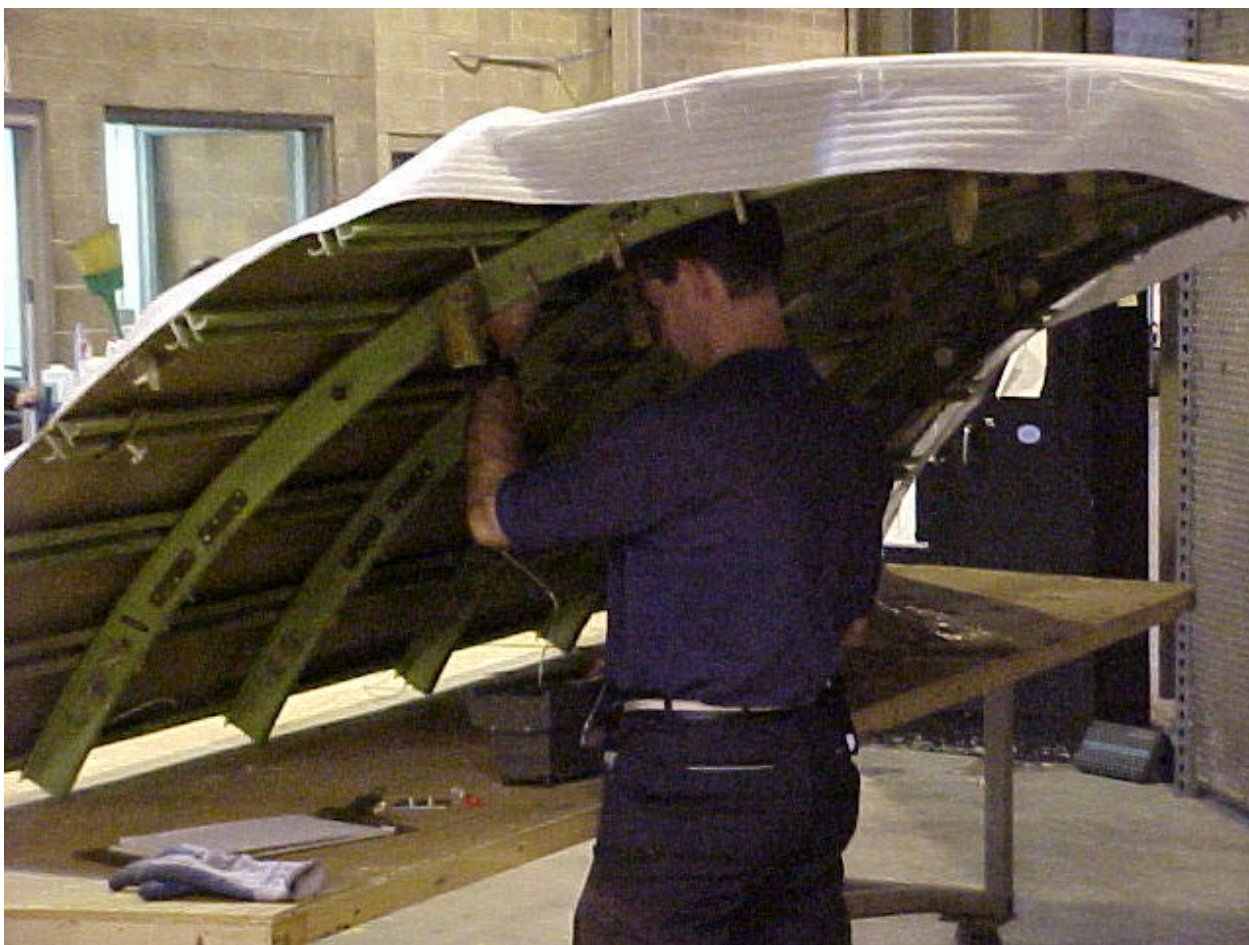
Figure 24. Photograph of internal MFEC being conducted.

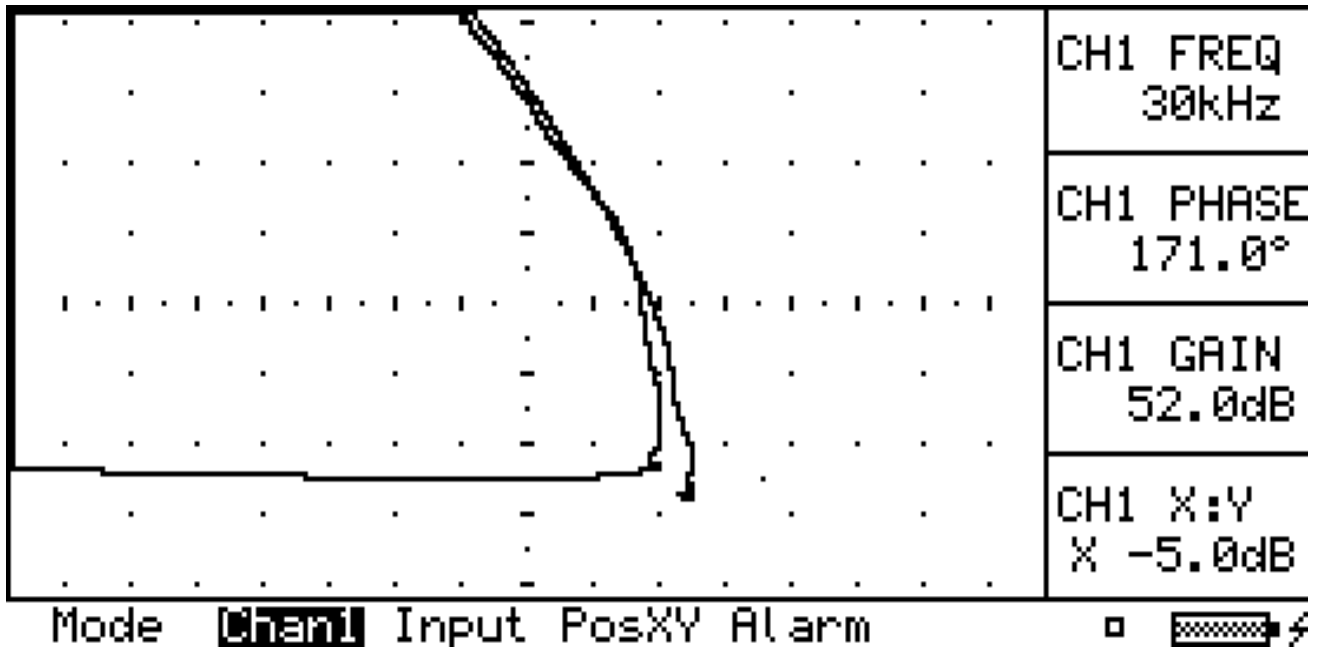
Figure 26. Screen representation of MFEC indication at stringer 4R, FS 720B, hole #7, forward side.

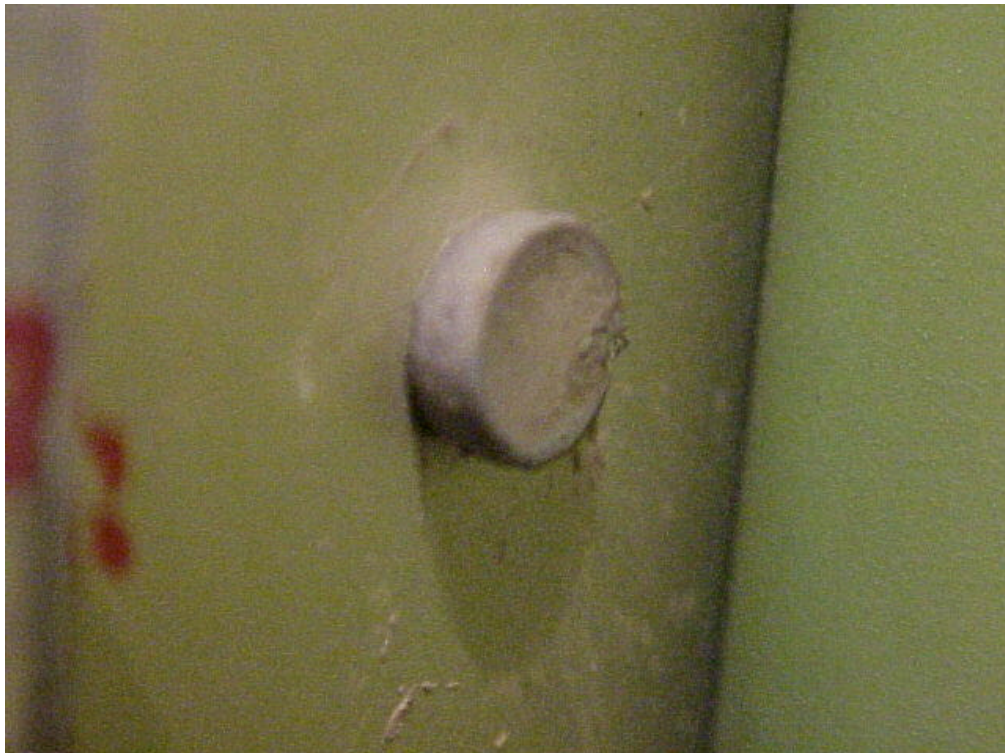
Figure 27 shows a representative photograph of cracks found during the detailed visual inspection of stringer 4R. Additional photographs showing indication locations can be found in Appendix D. Table 8 shows the crack parameters which were measured after discovery via the internal detailed visual inspection of the lower row of fasteners on the longitudinal lap joints.

Figure 27. Photograph of a visual indication on stringer 4L, BS 400, Rivet #11.

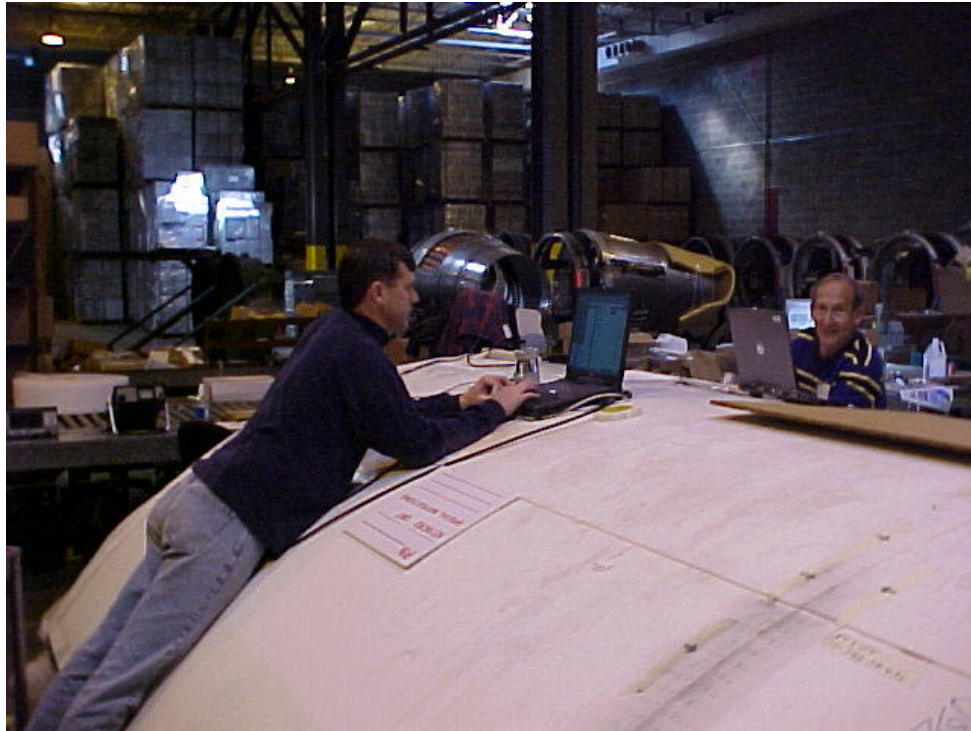
Figures 31-33 show the Rivet Check inspection being conducted on the panels. Figure 34 shows the erratic rivet alignment on the lower row of fasteners of the longitudinal lap joint which causes indications, making some fasteners uninspectable with Rivet Check. Figure 35 shows an external view of the erratic nature of the rivet alignment at the fasteners shown in Figure 34.

Figure 31. Photograph of Rivet Check inspections.

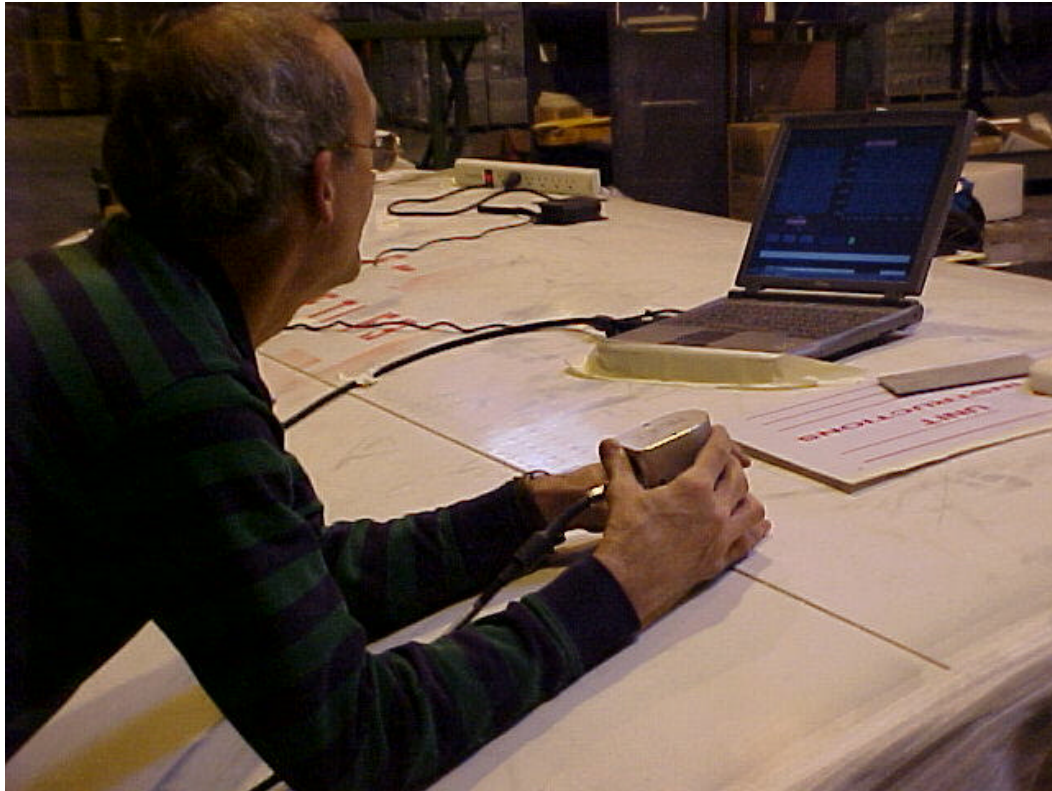
Figure 33. Photograph of Rivet Check inspection.

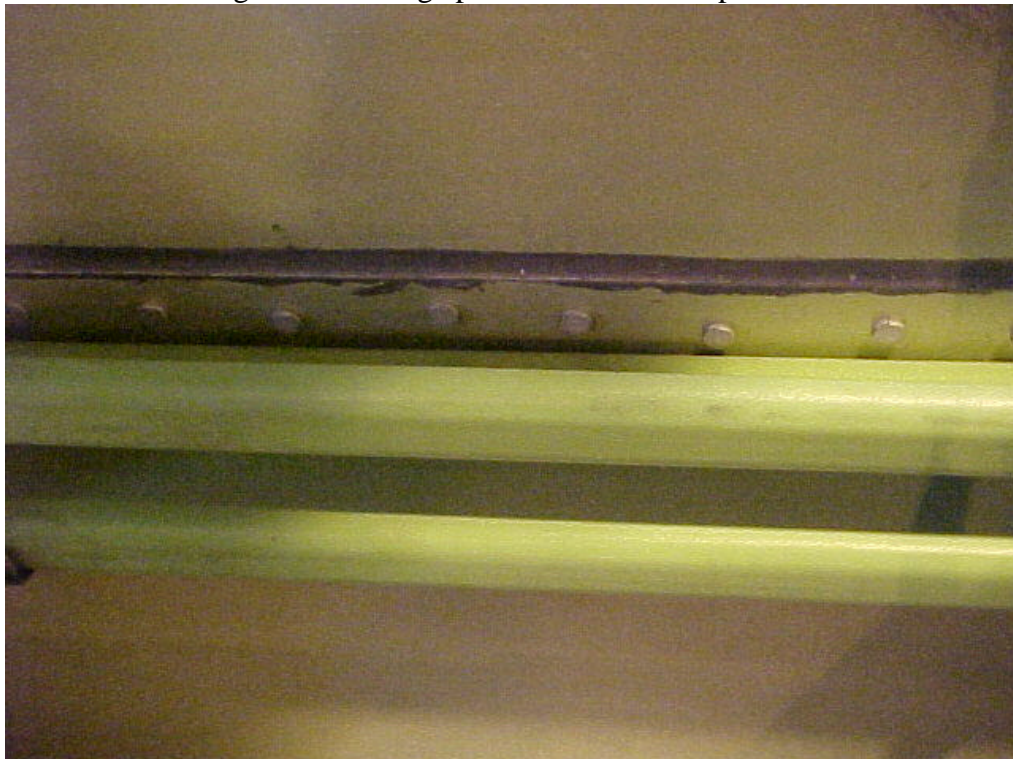
Figure 34. Photograph showing erratic rivet alignment, making some fasteners uninspectable with Rivet Check.

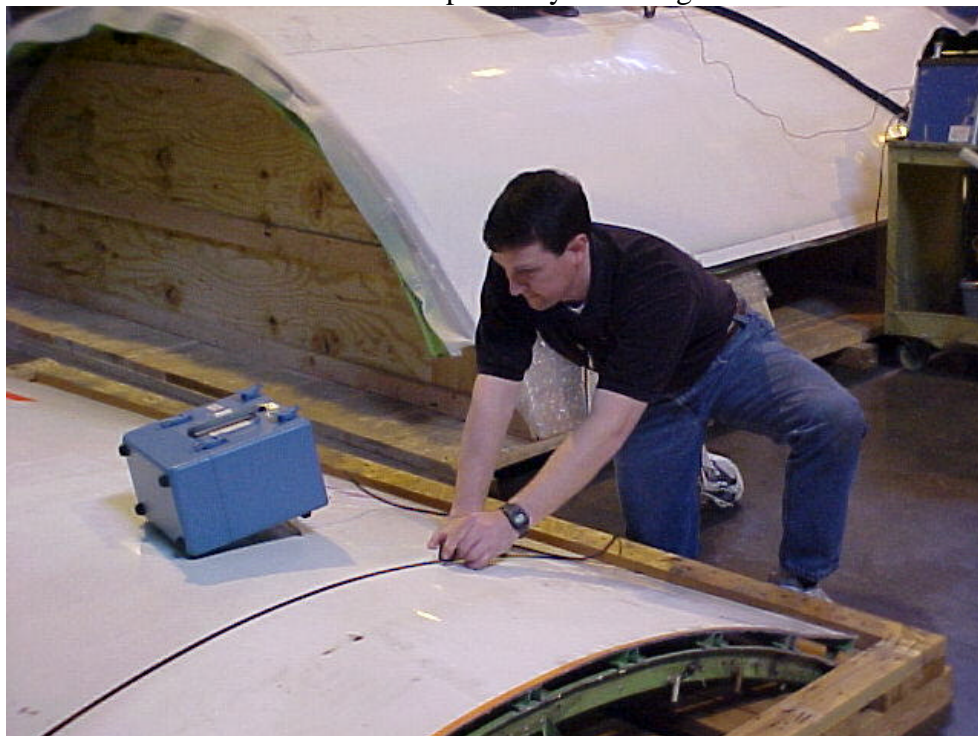
There were four areas of indications found during the ultrasonic inspection of the tear straps. These are shown in Table 11. Figure 36 shows a photograph of the inspection being conducted. A screen representation of a typical indication is found in Figure 37, and a photograph of the external surface shows the approximate location of the indication (Figure 38). Each of these areas contained a multitude of indications. Indications were found during inspections of tear-strap debonding at the circumferential butt joint at BS 360. This location does not have bonded tear straps, but does contain other bonded structure. However, these indications produced signals which were not consistent or similar to signals from consistently occurring structure. Appendix H shows the location of the indications from the external surface. Most indications were locations in the rivet pattern, between the rivets.

Figure 36. Photograph of ultrasonic tear-strap inspection.

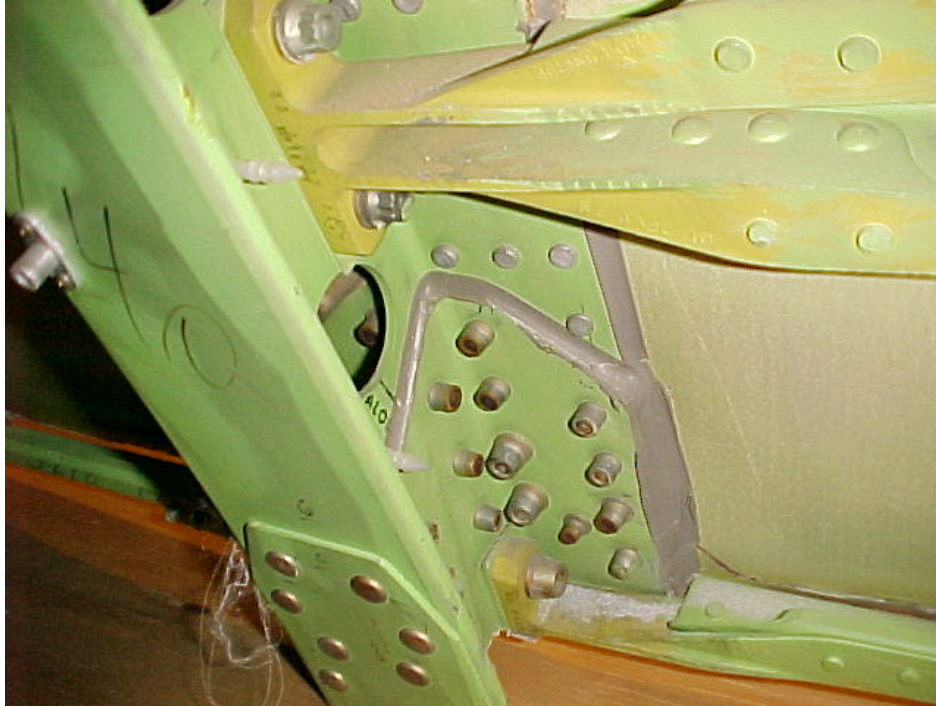
Figure 39. Photograph showing internal view of tear strap indication area at BS 740 between stringers 8L and 9L. No explanation for the indication could be found.

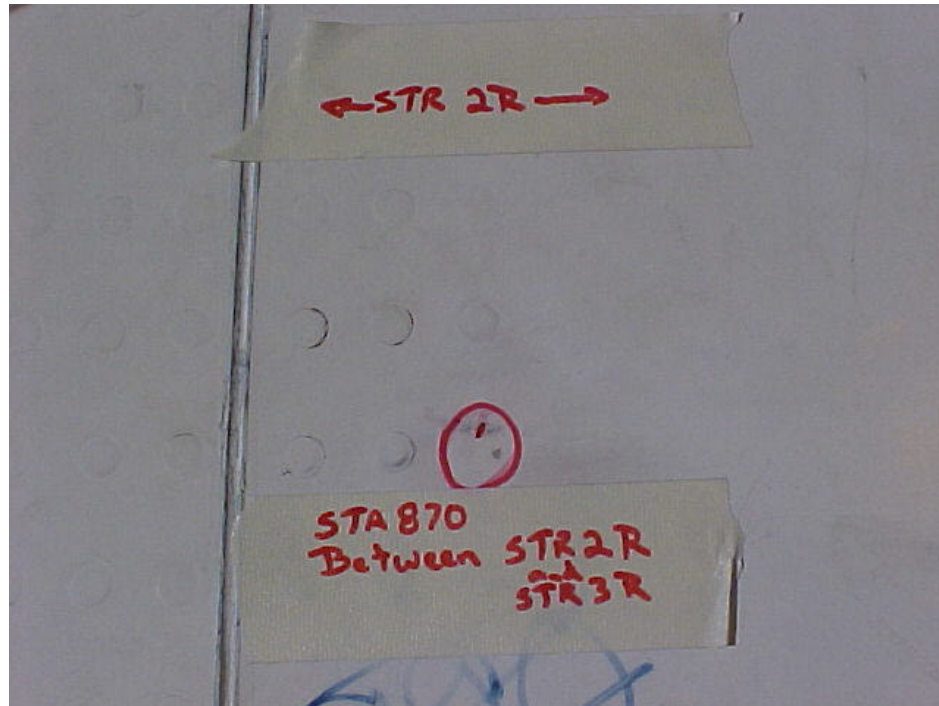
Figure 40. MFEC indication found at BS 870 between stringer 2R and 3R on the circumferential butt joint.

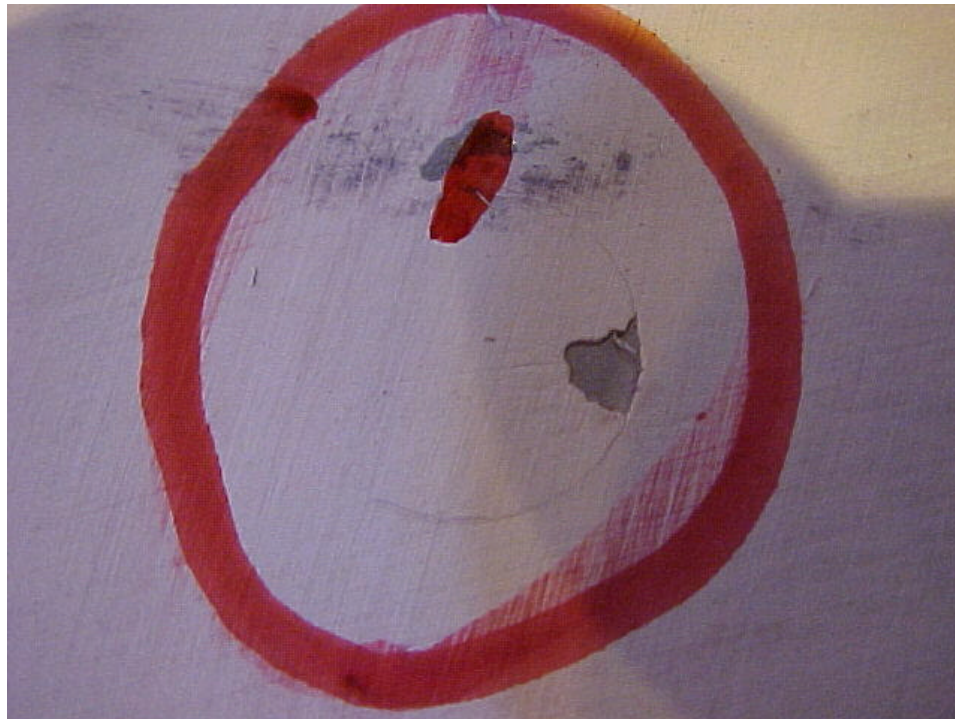
Figure 41. MFEC indication found on the top of the rivet at BS 870 between stringer 2R and 3R on the circumferential butt joint. Mark indicates location of MFEC signal.

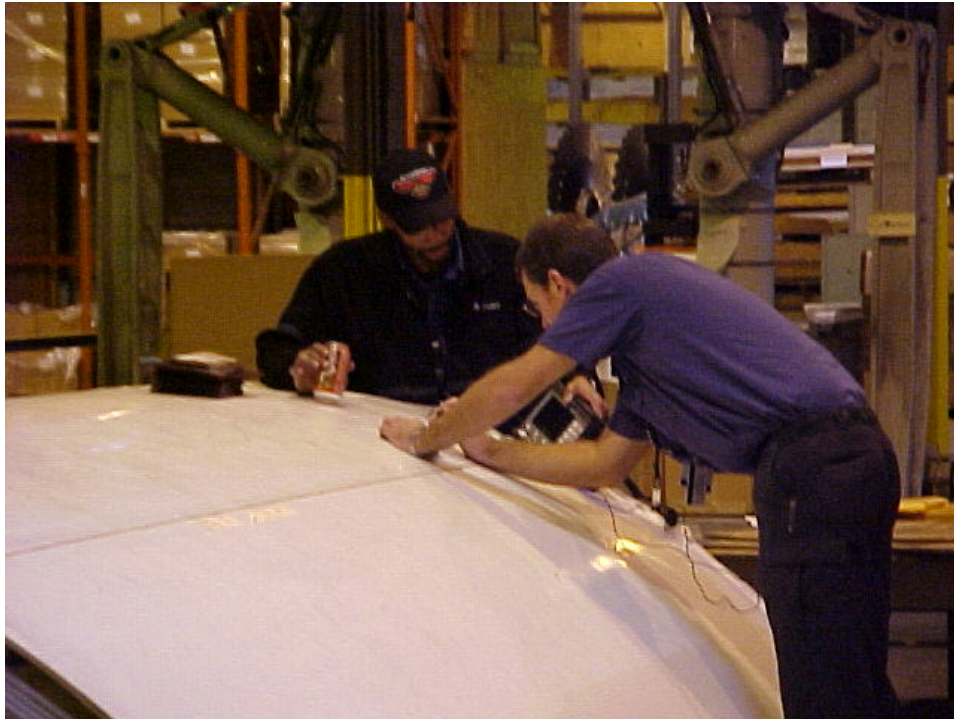
Figure 42. Photograph of external MFEC being conducted.

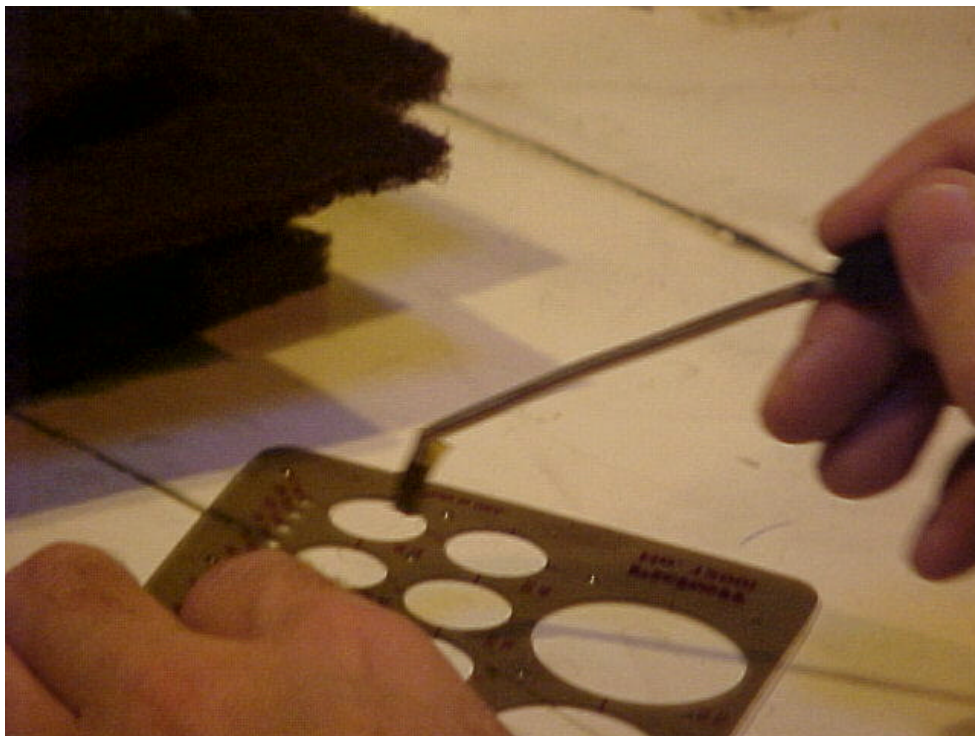
Figure 43. Photograph of external MFEC being conducted with the circle template.

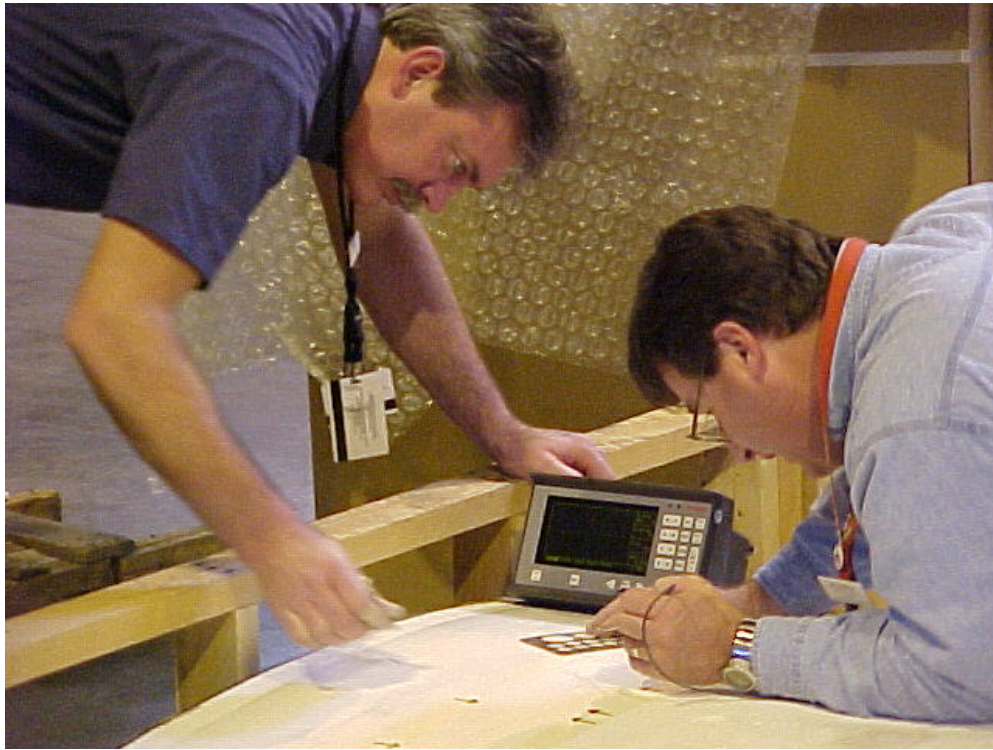
Figure 44. Photograph of external MFEC being conducted with the circle template.

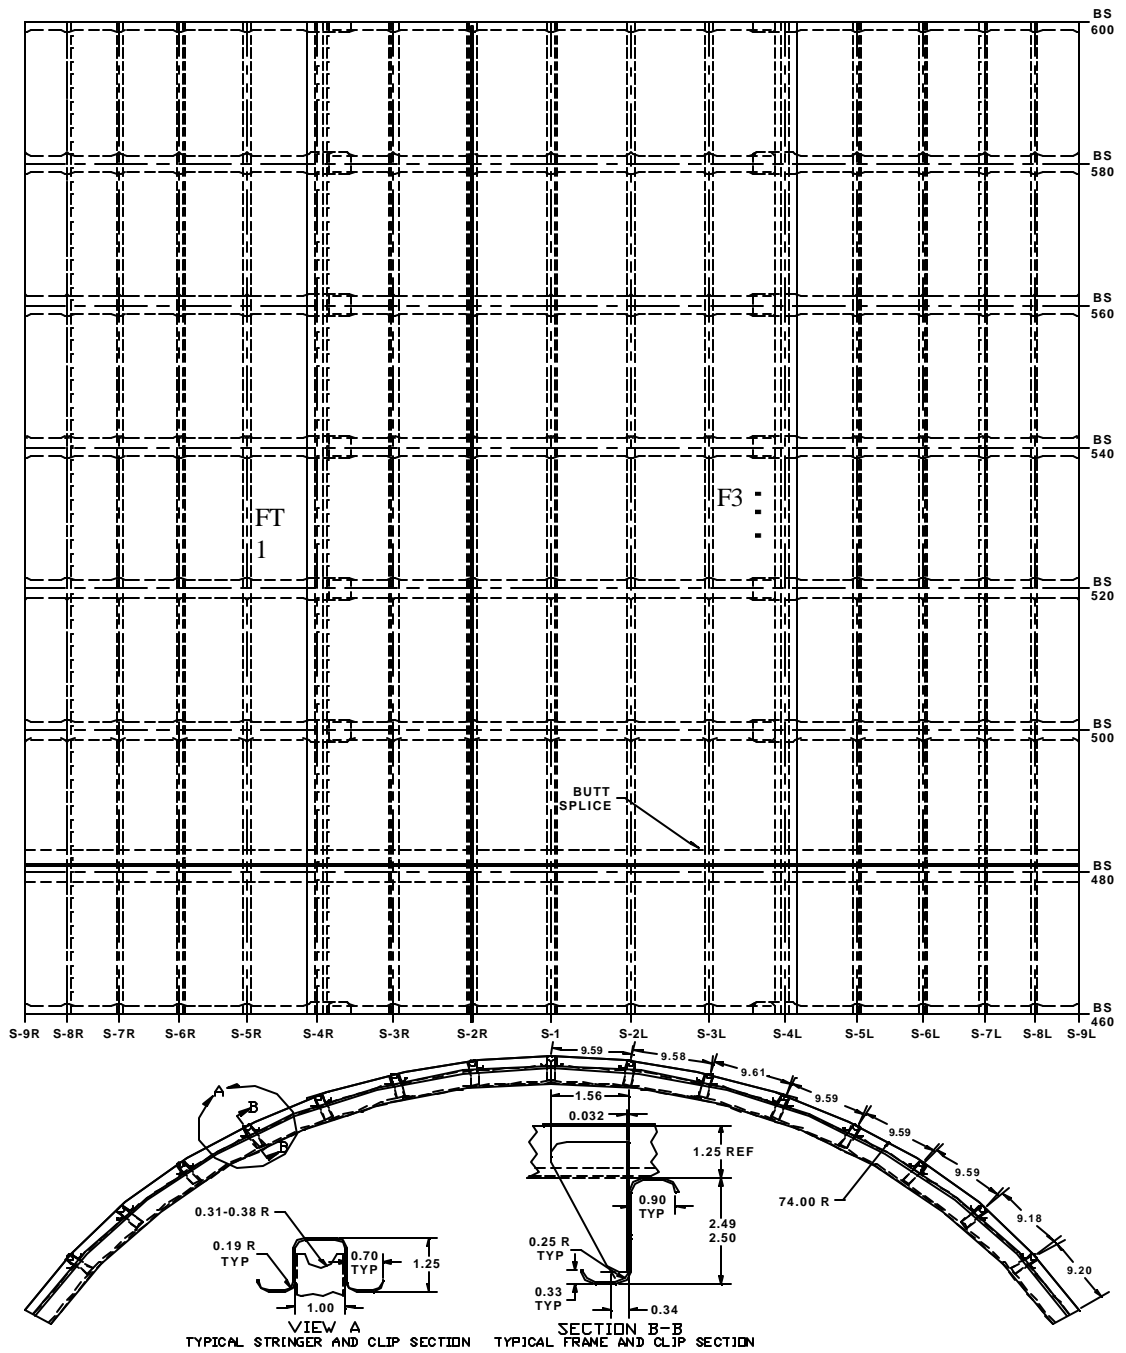
Figure 46. Engineering drawing of panel FT1/F3.

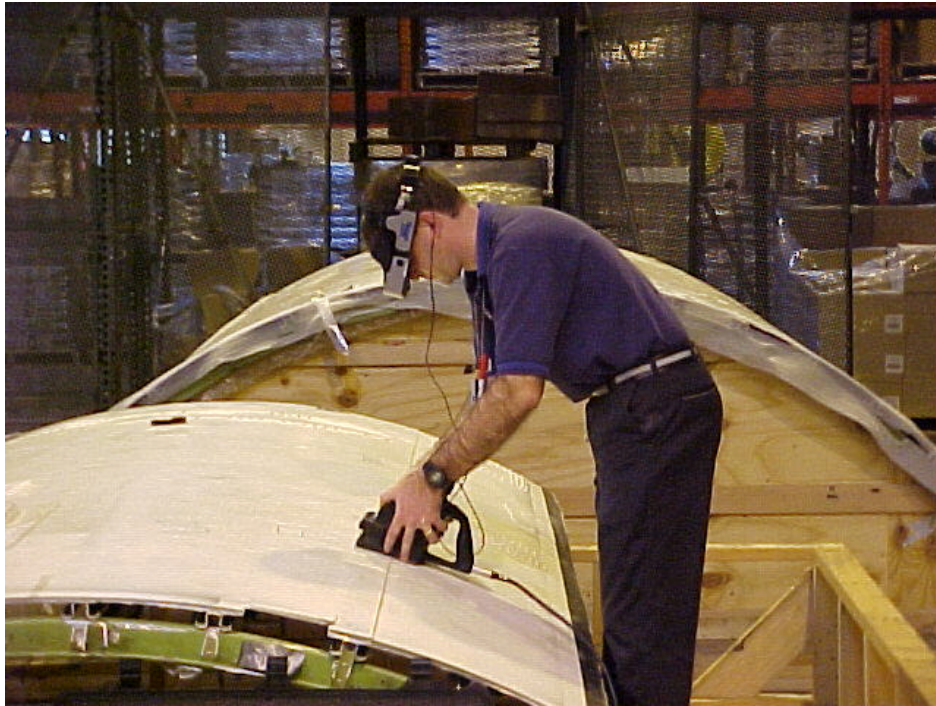
MOI was performed on all rows of the longitudinal lap joints. Figures 48 and 49 show the MOI inspection being conducted. The inspection revealed eight indications at six fasteners on the longitudinal lap joint at stringer 4R, shown in Table 17. No indications were found on the longitudinal lap joint at stringer 4L. Figure 50 shows a photograph of the external skin showing the location of the MOI indications found on the lower row of the longitudinal lap joint between BS 520 and BS 540. A screen representation of the indication found at rivet number 14 is shown in Figure 51. Cracks appear as elongated holes as described in Figure 8. Additional photographs and screen representations of all indications can be found in Appendix F.

Figure 48. Photograph of MOI inspection using wearable monitor.

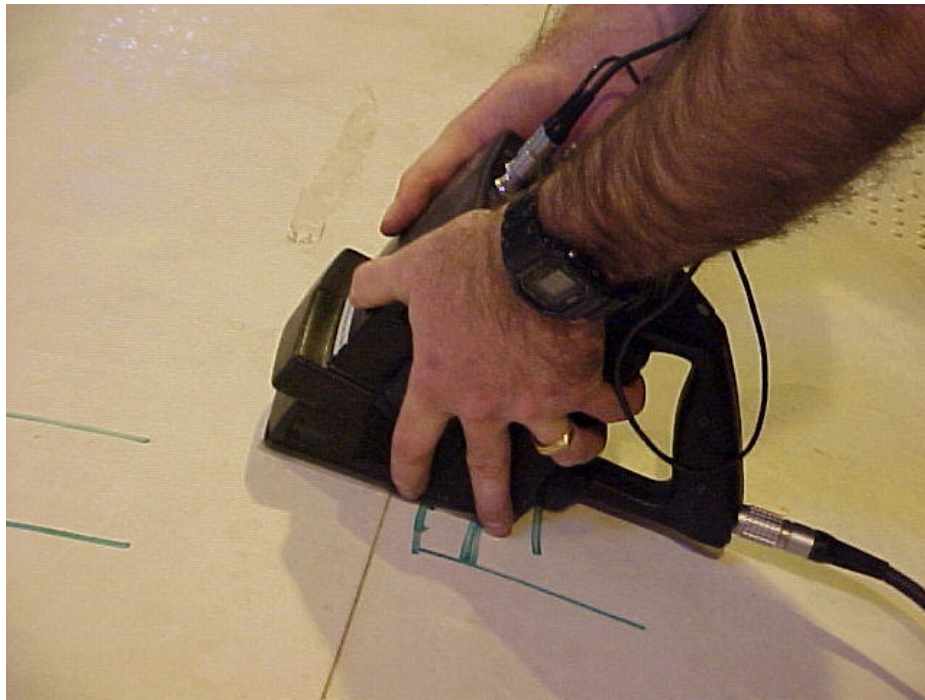
Figure 49. Close-up of MOI scanning head inspecting all rows of a longitudinal lap joint.
